## 530T MODIFICATION

### Power and Ground Connections

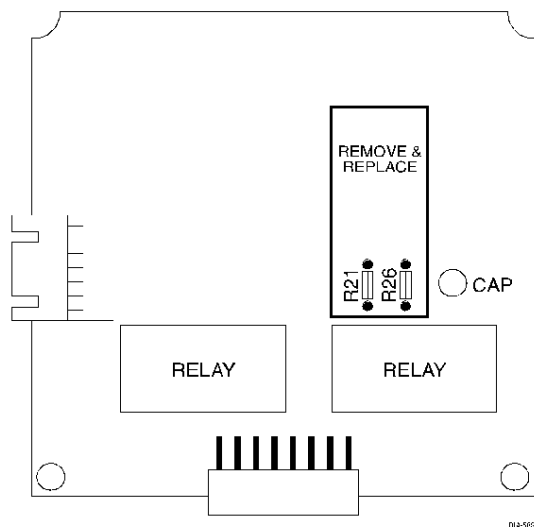
1. The resistors to be replaced are R21 and R26 as outlined on the circuit board below. These are the default resistors in the system; replacing these resistors will be the same as adding two more settings to the dipswitches.
2. Desolder these resistors and replace them with 150ohm 1/4watt resistors. Exceeding 150ohms when replacing these resistors could lead to failure of the window motor and/or module.

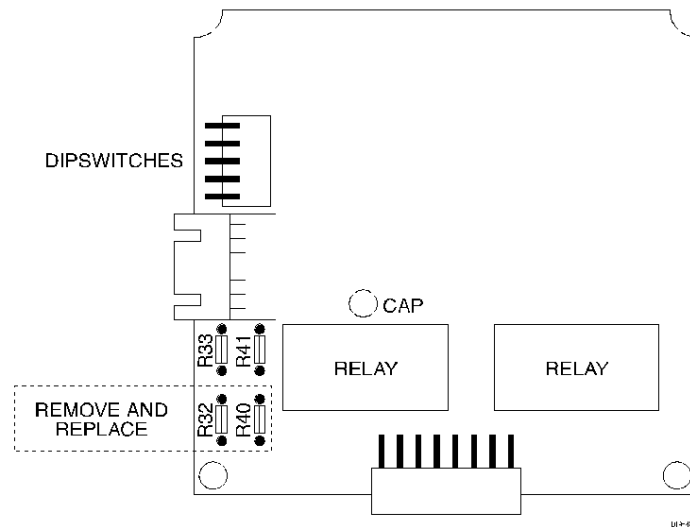
**Diagram A. Window Motor Circuit Board**

1. The resistors that need to be replaced are R32 and R40, as shown in **Diagram A**. These are the default resistors in the system. Replacing these resistors will be equivalent to adding two more settings to the dipswitches.
2. Desolder these resistors and replace them with 150 ohm 1/4 watt resistors. **WARNING!** Exceeding 150 ohms when replacing these resistors could lead to failure of the window motor and/or module.
3. Return the dipswitches to the low setting and adjust only as high as is necessary to perform the task.

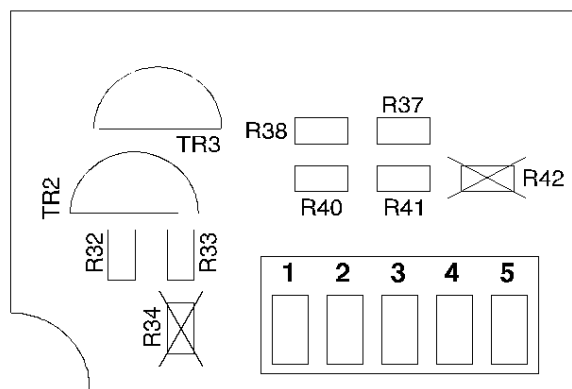
**Diagram B. Top of PC Board**

1. Resistors R34 and R42 in **Diagram B** must first be removed from the PC board. Place the tip of a sharp pick tool under the resistor and pry it off the PC board. Be careful not to damage the other components on the board.

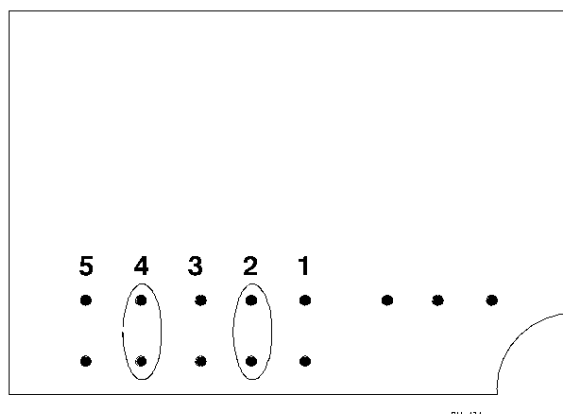
**Diagram C. Bottom of PC Board**

2. Turn the PC board over and locate the solder locations for Dipswitches 2 and 4 as shown in **Diagram C**. Add a 200 ohm resistor across the contacts. After making this modification, Dipswitches 2 and 4 *must* be set to the OFF position.

3. After the resistor has been added, the minimum resistance value for the unit will be 250 ohms. The previous maximum resistance value for the unit on high setting was 200 ohms.

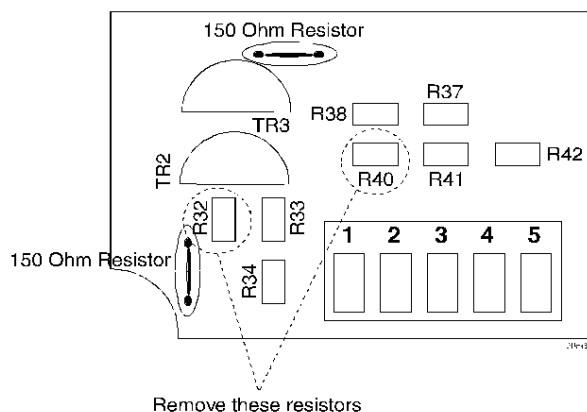
**Diagram D. Top of PC Board**

Beginning with date code 0K/0K a resistor was added to the circuit board to aid in ease of modification to the 530T. If the 530T does not roll the windows up all the way, then the surface mount resistors (R32/R40) can be removed to allow for a higher resistance setting as shown in **Diagram D** below. This will compensate for some of the larger power window motors. This is the equivalent of adding two more steps to the dipswitch settings. After removing R32/R40 reset the dipswitches to the low setting and adjust only as high as is necessary to perform the task.
